**PROJECT REPORT**  
**TRAIL MAINTENANCE PROJECT AND HABITAT RESTORATION**  
**Torres del Paine National Park, Patagonia, Chile**  
**Mar 15, 2008 to Mar 30, 2008**

Prepared and Compiled by  
John P. Hollinrake, Project Leader

Conservation Volunteers International Program  
PO Box 61912  
Santa Barbara CA 93160  
[www.conservationvip.org](http://www.conservationvip.org)

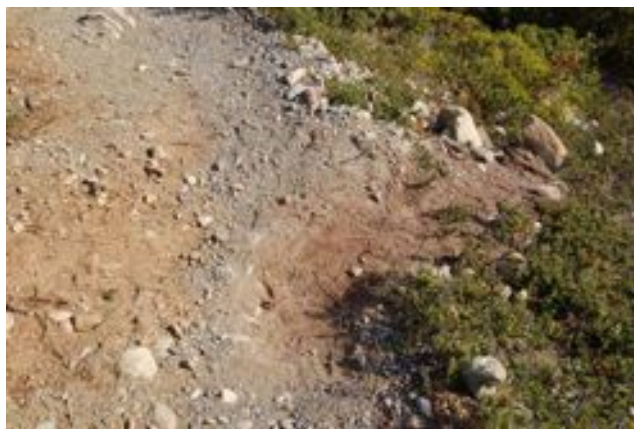
**Example of Drain on Trail**

A total of 172 drains were built by the project team. Drains were particularly needed at regular intervals along the existing trail to allow water to flow off the trail to prevent erosion. The existing trail had not been constructed with such drains, thus significant erosion had occurred. Drains were placed in all areas where it was evident that water was flowing down the trail causing soil erosion. Drains are probably the most important improvement to existing trails. Drains will not only prevent soil erosion, but prevent rocks and boulders from being exposed on the trail tread, and prevent hikers from creating new trails to avoid wet and muddy trail sections.

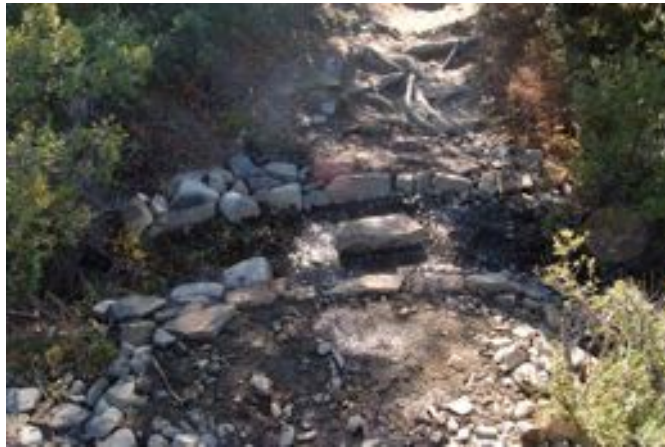
There are several major stream crossings on the trail above Lago Skottsberg. These stream crossings were causing major erosion and year round water running down the trail. Large sections of mud forced hikers to deviate from the trail and create alternative trails, leading to further erosion.

**Example of Major Stream Crossing Channel Project**

Two significant stream crossings were channeled by volunteers, by digging deep open channels across the existing trail, and lining the channels with large rocks and boulders obtained from the area. Large rocks were placed strategically to enable hikers to easily walk across the channels, and to encourage hikers to remain on the existing trail. The results of building the drains could be immediately observed, because all water that had previously run down the trail was eliminated, and the trail was dry in one day.

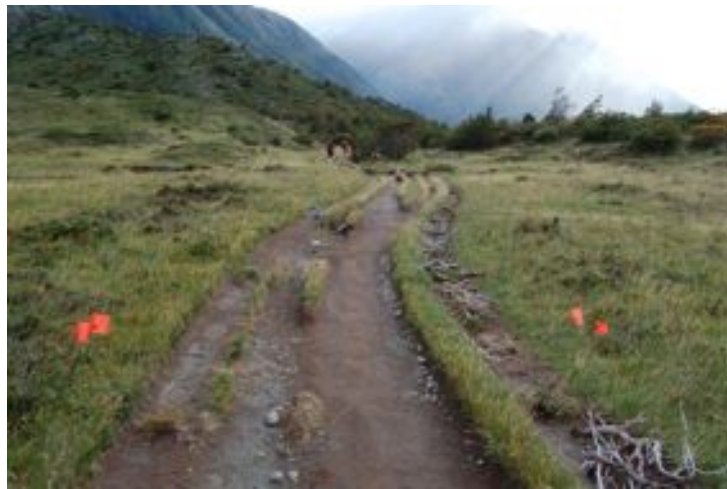
fill with water, forcing hikers to set off the trail, creating yet another trail. At the time of this project, the meadow had in some areas five trail treads, each 15 cm. or more in depth. This natural aesthetics of the meadow was significantly impacted by the “braided” trail, and was impacting heavily on the fragile wet meadow. The only solution was to close the existing trail and built a new trail across the slope of the southern hill surrounding the meadow. In addition, the existing trail in the meadow needed to be restored and access to the old trail camouflaged to eliminate future use.

**Meadow With Braided Trails Prior to Restoration**

A new trail route was surveyed by Conservation VIP leaders and marked for clearing and construction consistent with current trail design methodology. Two teams of volunteers and several CONAF Rangers cleared brush and shrubbery and cut the trail into the slope. The cut brush and shrubbery was used to camouflage the western section of the closed trail where deep eroded ravines had been created creating a serious erosion problem, and a hazard to hikers.

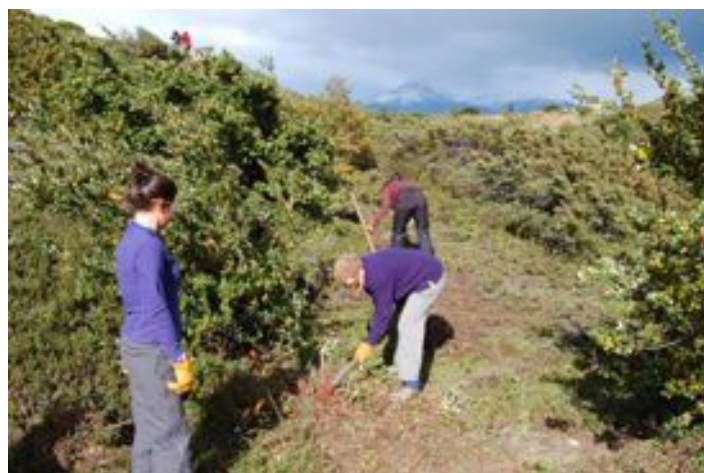
**New Trail Construction, Clearing the Vegetation**

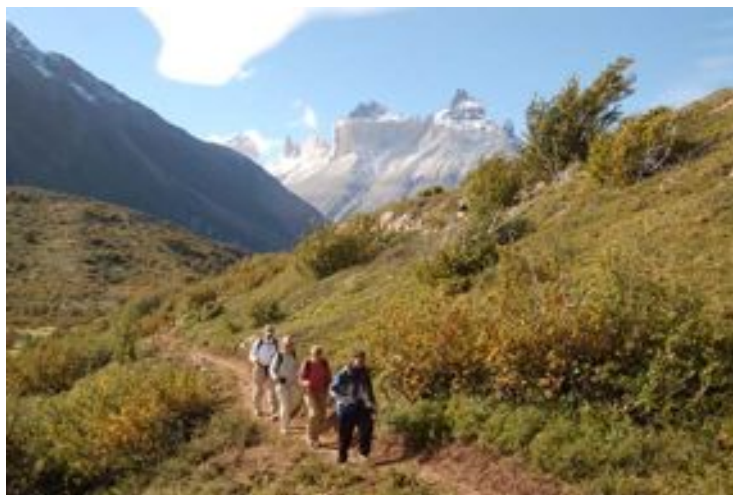
Over the course of one week, the volunteers placed drains, placed boulders to assist in shallow stream crossings, built erosion control water bars, and placed gravel in the northeastern section of the trail where it lay in a flat area at the edge of the meadow. The trail was opened to hikers on the third day of construction while drains and water bars were constructed. Hikers were observed eager to use the new trail, and through interviews with some hikers, most understood that the trail had been re-routed to prevent traversing the fragile meadow habitat. The new trail opened up a new vista of Lago Skottsberg, which hikers greatly admired.

#### **New Trail Being Used by Hikers**

*\*It is HIGHLY recommended that CONAF place signs at both ends of the former meadow trail indicating the meadow trail is permanently closed to allow meadow restoration. CONAF will need to monitor the area closely to ensure that hikers do not use the old trail. Grasses and shrubs that were planted by the volunteers to restore the meadow and eliminate the trail will need to be monitored and additional plant plugs replaced as needed.*

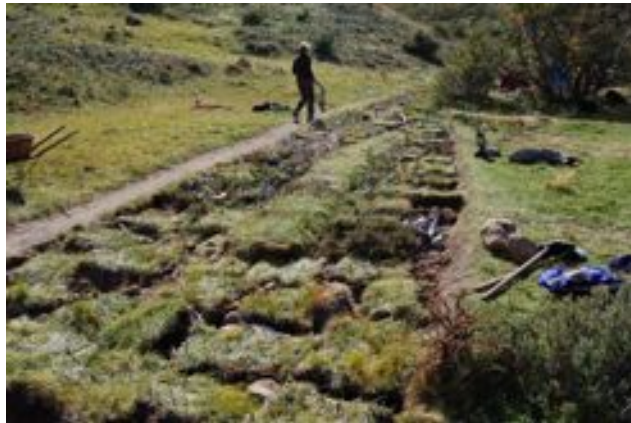
**Grass and Shrubbery Plugs in Meadow Trail - Remaining Path was later Scarified for Seed Embedding**

Volunteers cut plugs of grasses and shrubbery from the meadow area outside of the viewshed, and placed these plugs into the closed trail treads. In some areas, nearly 100% of the trail tread was filled in with these plugs. In other areas, a checkerboard pattern of plugs was used, and dead vegetative material was used to fill in the gaps. It is anticipated that the live plants and grasses will migrate into the gaps as the dead vegetative

material decomposes. Emphasis was placed on 100% coverage of the old trail where the new trail begins at the northeastern edge of the meadow to restore the aesthetic beauty of the meadow, restore the habitat, and prevent future use of the old trail.

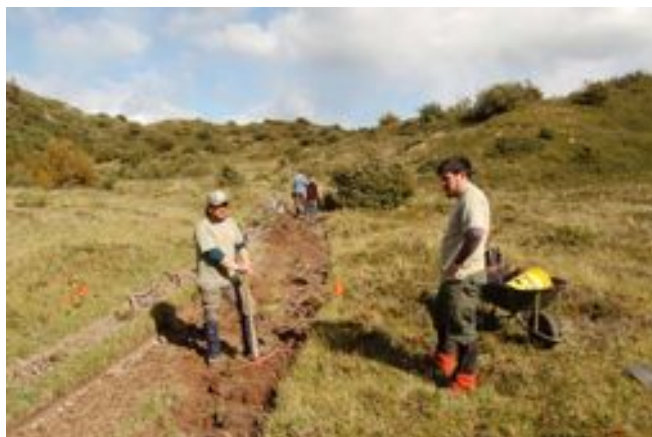
The camouflaging was very effective, and the old trail is now completely hidden from view as one approaches the trail from the crest of the western ridge above the meadow.

The western portion of the old trail where it drops from a ridge down into the meadow area had been seriously impacted by erosion, resulting in numerous ravines and gullies. CONAF Rangers and volunteers placed significant amounts of cut brush and shrubbery, and dead shrubbery and trees from the area to hide the former trail and promote re-vegetation as the seeds fall off the cut shrubbery, and the dead material decomposes. Additionally, and importantly, the trail tread that could not be covered with plant material was scarified with pick axes to turn up the soil and enable seeds to embed in the fresh soil and sprout in the spring.

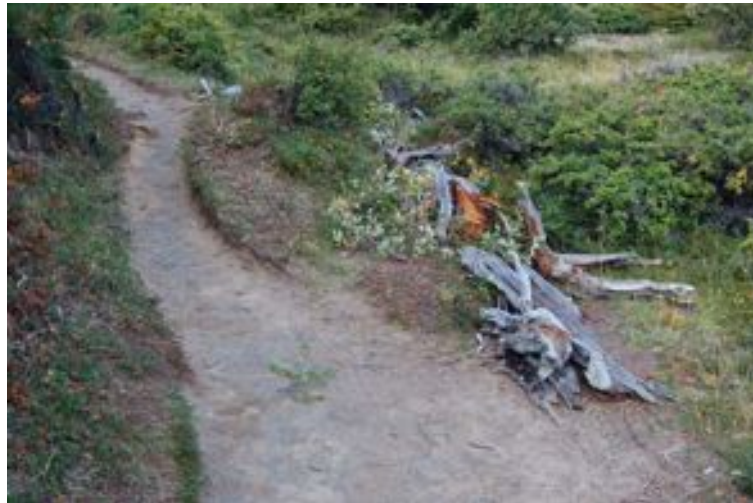
**Example of Closed And Camouflaged Trail Tread**

Where possible, the closed trail treads were camouflaged with tree branches, dead shrubbery, and rocks.

*RECOMMENDED THAT CONAF monitor these problem areas and continue to maintain the drain improvements on the that will prevent hikers from creating new trails in the future.*

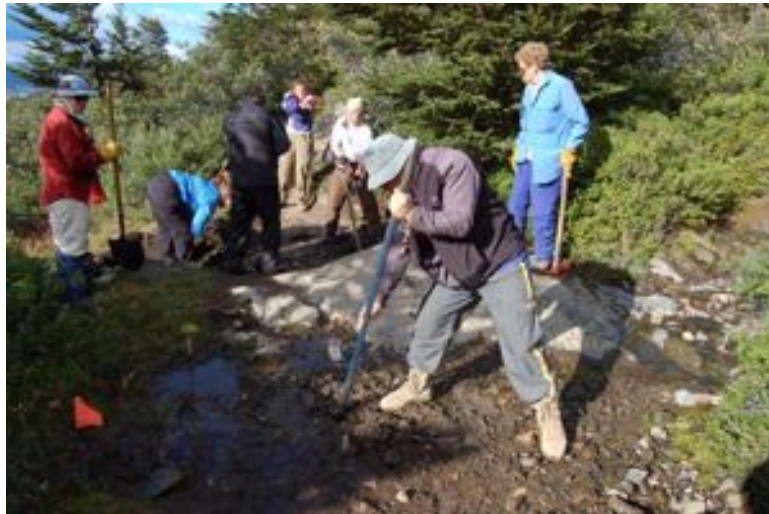
**Removal of Rocks Near Stream Crossing**

Large rocks and boulders, some weighing 100 kg. were removed by volunteers using rock pry bars and brute force. These rocks were exposed

during the past years by water and soil erosion. These large rocks posed a safety threat to hikers due to possible trip and fall accidents. Removal of these rocks and boulders also prevents hikers from creating new trails to avoid these obstacles.
