Volunteer Trip Report Torres del Paine National Park, Patagonia March 16 – 26, 2026

Torres del Paine March 2026 Volunteer Trip Report Executive Summary

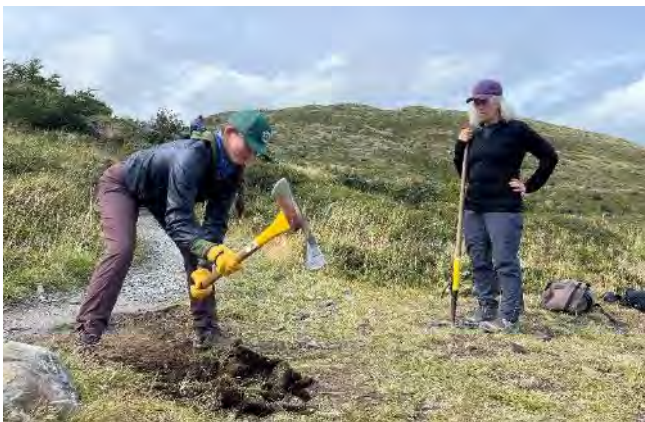
Figure 21: A team of 2 begins construction of a new water bar.

After a safety briefing on how to carry tools, the group proceeded about ¼ mile up the trail toward Italian Camp. There, the group gathered for a group stretch, in-depth safety tutorial about each tool, and an outline of the next project. This afternoon and for the next three days, the project focus was on construction of water bars. Water bars are a type of drain feature used to divert water off the trail. Diverting water is critical to prevent erosion of a trail system and keep hikers on the trail, for long-term sustainability and protection of the landscape. The projects offered the group the opportunity to learn how to place, construct and maintain these important trail features.

In groups of 2 - 3, the ConservationVIP® travelers spread out along the identified section of trail and began to install new water bars. The group enjoyed a sunny and wind-free afternoon, the warmest of the week. At the end of the day, tools were stashed off-trail and concealed from view, ready for collection the following day. Back at Paine Grande, some members of the group enjoyed a cool beverage on the patio, while others opted for a shower or afternoon hike before dinner. Day 2 in the books!

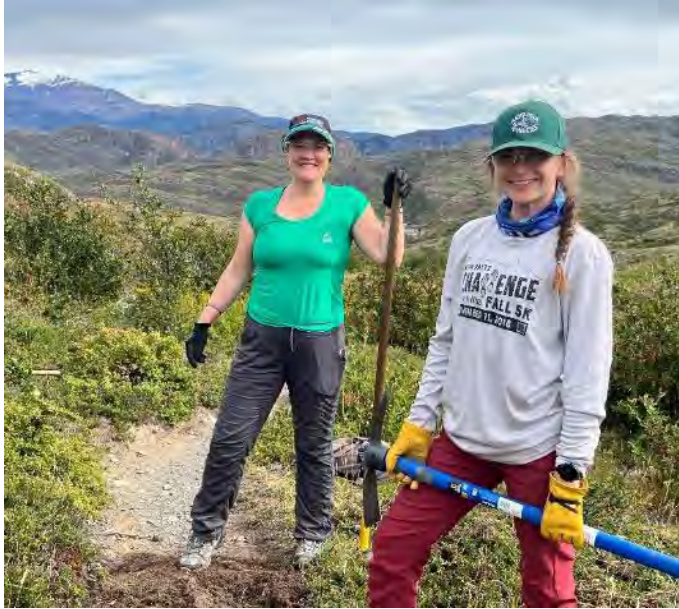
Figure 22: A team of 2 pauses construction of a new water bar

After breakfast, the group set out on the trail toward Italian Camp, pausing to collect tools stashed the prior afternoon. Leap-frogging up the trail in groups of 2-3 (**Figure 22**) to locations flagged by the Trip Leaders, the group continued to construct new water bars and soon reached the turnoff point for Skottsberg Trail.

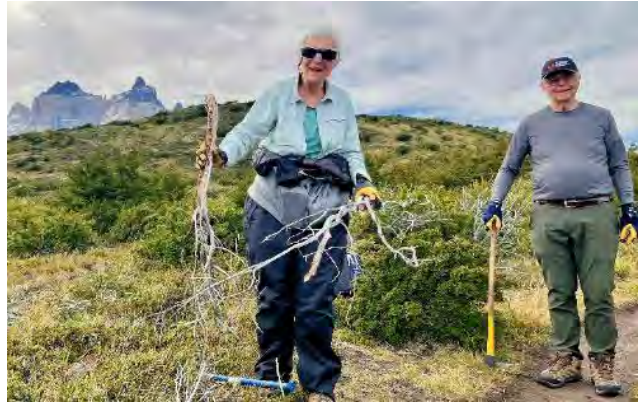
Figure 23: A team of 2 collects loose vegetation to aid recovery on closed off, braided trails.

itself in the tracks. The recovery was aided in some areas by lightly loosening compacted earth at the surface of the track before concealing the area with duff, downed branches (*Figure 23*), and other loose plant material (*Figure 26*).

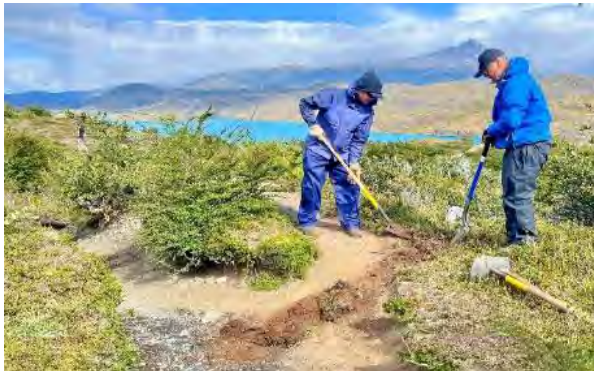
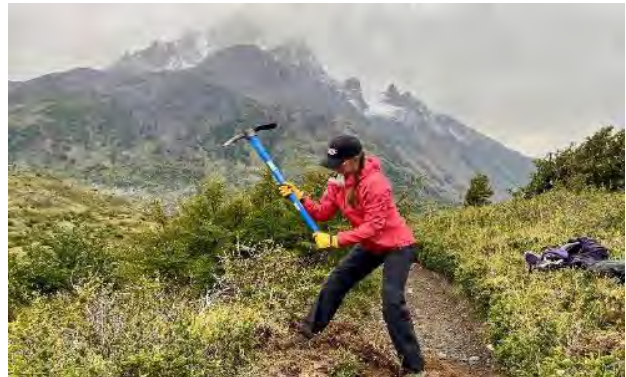
Figures 24-25 (Left-Right): Travelers begin construction of new water bars, cutting into established banks.

Back on the “old” trail toward Italian Camp, the group returned to construction of new water bars. Given the worn nature of this section of trail, the task was laborious. It required making deep cuts through established banks (*Figures 24, 25*), to make way for water to drain. Three teams remained committed to water bar construction, while others opted for brushing, concealment of braided tracks, and a small amount of trail revegetation. At the end of the day, tools were once again stashed off trail and out of sight.

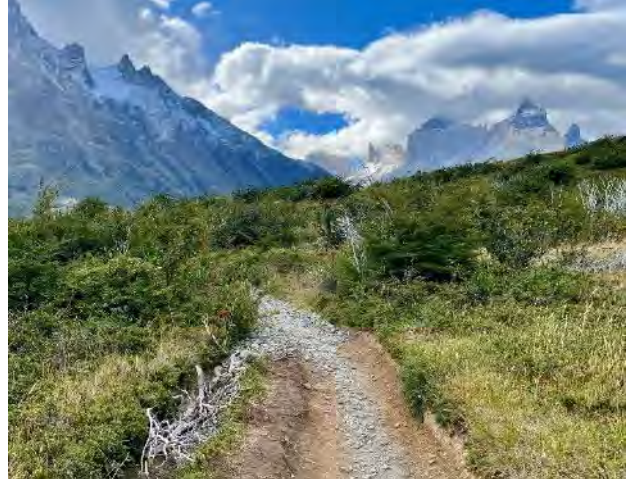
Figure 26: A section of braided trail is concealed by downed branches.

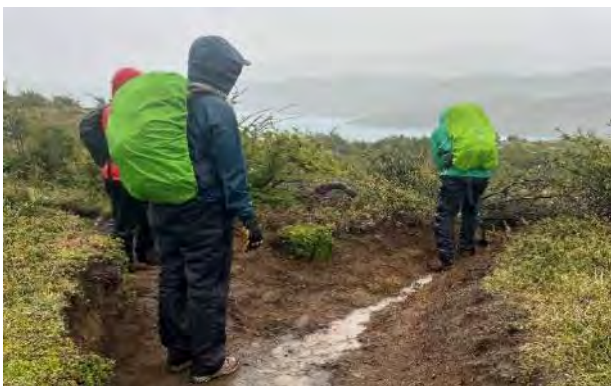
Figure 28 (Lower Left): The group can see a newly constructed water bar in action as rainwater is diverted off the trail; Image also shows a revegetated social bypass, directly at photo center (see Fig. 24 for before)

Returning to the location where tools had been stashed along the “old” trail to Italian Camp, the group continued installing water bars, brushing, and concealing braided tracks along another 1/4-1/2 mile of trail. Clouds loomed overhead most of the day, concealing the peaks and bringing the wettest day yet. With more rain came wet and muddy conditions! The group persevered and accomplished much. Smiles abounded as the group could see their water bars in action by the end of the day (**Figure 28**)!

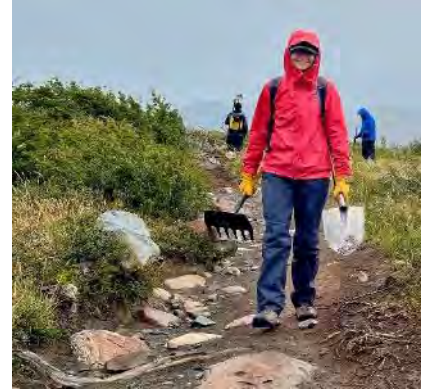
Figure 31 (Lower Left): Revegetation in action!

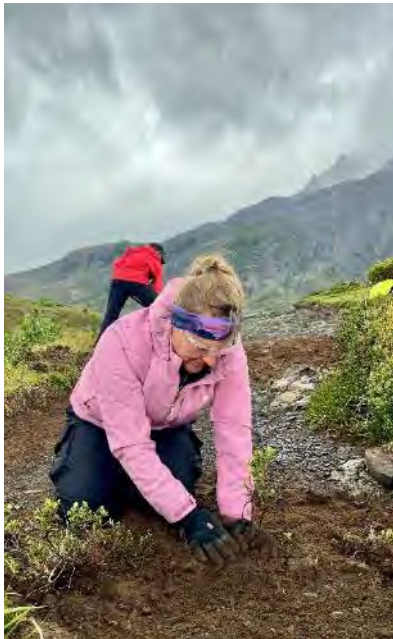
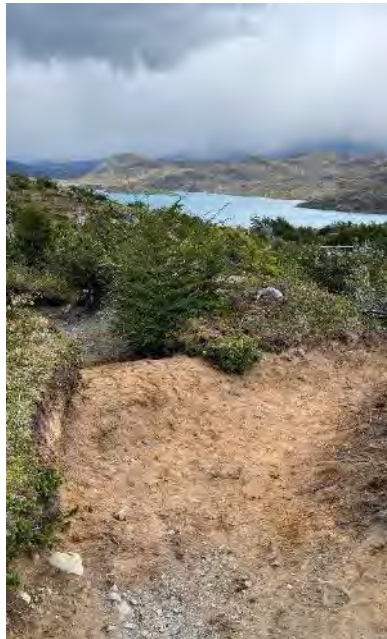
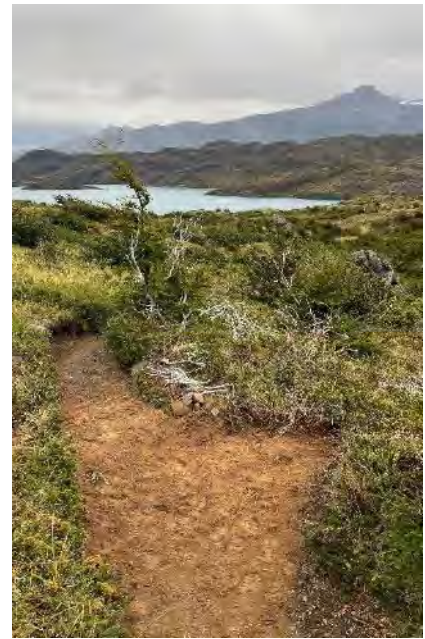
Figures 32-33 (Lower Center & Right): Newly constructed water bars

Because this would be the group's final day of water bar construction, all tools were collected for return to the Paine Grande Ranger Station. Along the way, teams paused briefly to inspect and make final adjustments or corrections to the newly constructed water bars.

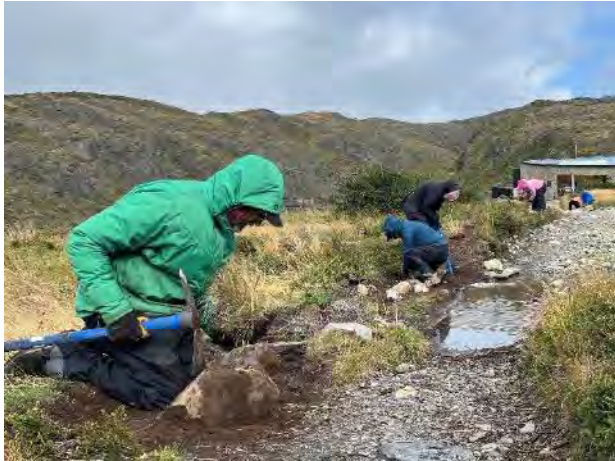
Figure 35 (Top Left): the group revegetates a widening section of trail.

Selecting new tools appropriate for revegetation (hoes, shovels, mattocks) and some rock removal (shovels, pickaxes, buckets), the group set out to revegetate approximately 150' of worn trail. Rocks were dug in at anchor points to deter foot traffic through the route, plant material was harvested and replanted in the light patches, and duff, downed branches and plant material were used to conceal deeper braided tracks.

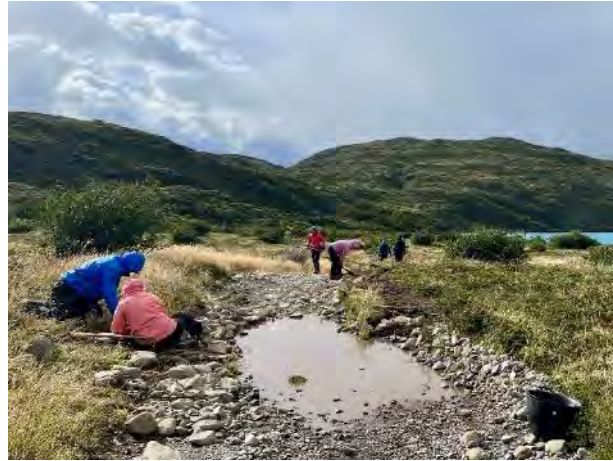
Figure 36 (Top Right): the group revegetates a puddle bypass and provides rock fill to allow the main trail to be passable.

In parallel, a team of two focused on widening and improving an undersized outlet at the end of a water pipe coming from the Ranger Station, alleviating backup and flooding onto the trail. Another group of two collected rocks to infill one of the deepest puddles (**Figure 36**), creating a route for hikers to remain on trail, rather than continuing to erode the edges.

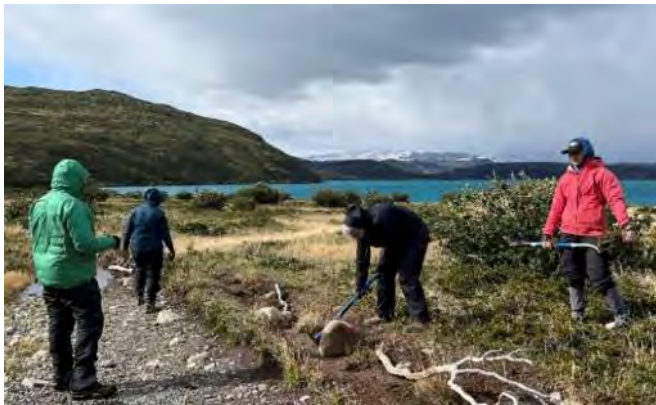
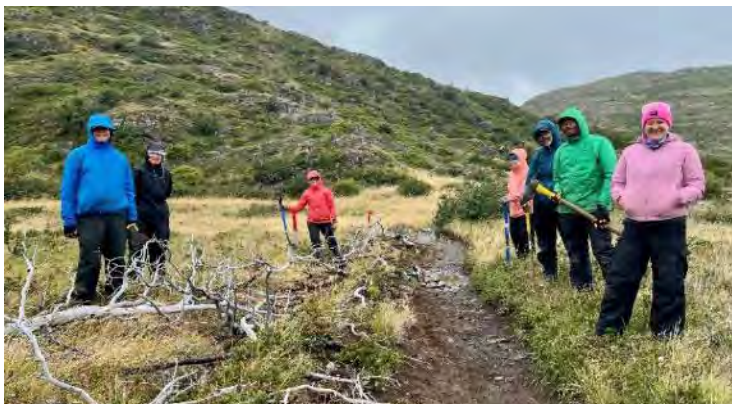
Figure 37 (Above Left): the group revegetates and conceals a newly worn bypass trail.

Figure 38 (Left): the group flanks a section of bypass trail that has just been revegetated and concealed.

Given the high volume of visitors in and out of Paine Grande, areas directly in front of the refugio and Ranger Station needed maintenance and restoration. A few sections of trail had been identified by Trip Leaders earlier in the week as prime locations for recovery, if given a little TLC. Specifically, trail braiding and widening around puddles was just starting to occur in a few areas – vegetation was being worn and roots were exposed, but the plant life remained. These sections, if protected from further damage, would quickly regrow.
