## Volunteer Trip Report Torres del Paine National Park, Patagonia March 16 – 26, 2026

### Torres del Paine March 2026 Volunteer Trip Report Summary of Accomplishments

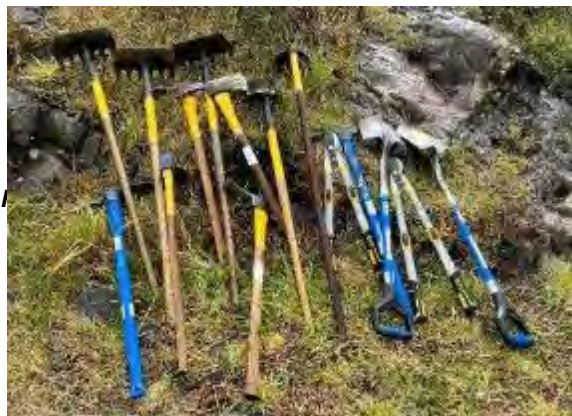
**Figure 19:** Many of the project tools

After lunch, it was time to switch gears! First stop was the Paine Grande Ranger Station where Corporación Nacional Forestal (CONAF) had kindly stored ConservationVIP's tools. The tools had been coordinated ahead of time by Trip Leaders, together with help from Legacy Fund and CONAF. Tools for the next few days' projects included shovels, pickaxes, pick Mattocks, Pulaskis, McLeods, loppers, and hoes (*Figure 19*).

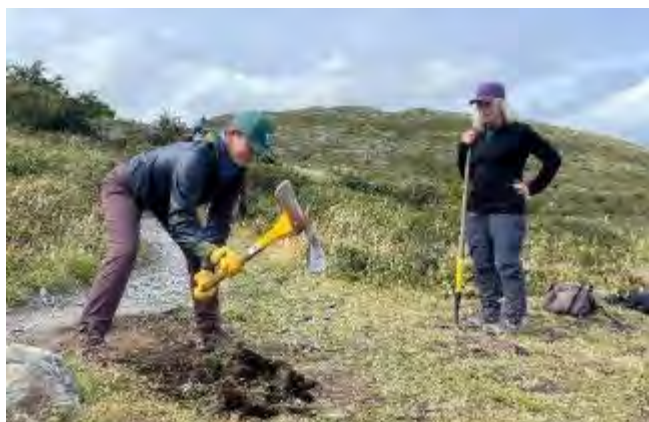
**Figure 21:** A team of 2 begins construction of a new water bar.

After a safety briefing on how to carry tools, the group proceeded about ¼ mile up the trail toward Italian Camp. There, the group gathered for a group stretch, in-depth safety tutorial about each tool, and an outline of the next project. This afternoon and for the next three days, the project focus was on construction of water bars. Water bars are a type of drain feature used to divert water off the trail. Diverting water is critical to prevent erosion of a trail system and keep hikers on the trail, for long-term sustainability and protection of the landscape. The projects offered the group the opportunity to learn how to place, construct and maintain these important trail features.

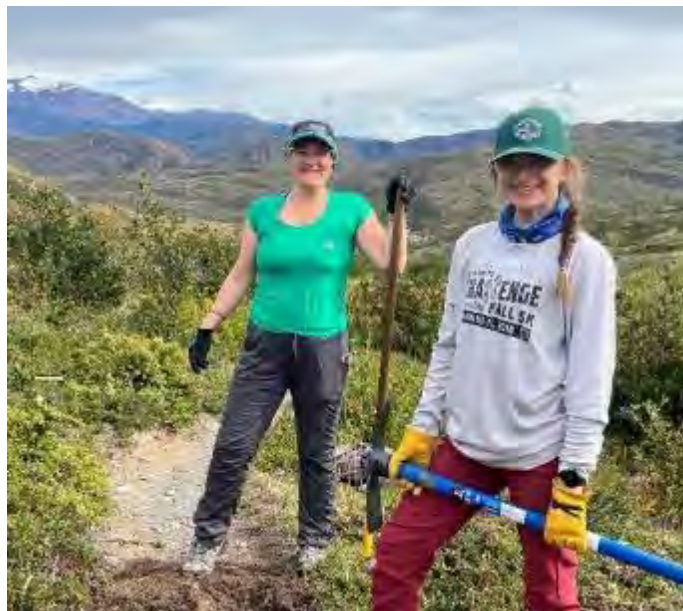
**Figure 22:** A team of 2 pauses construction of a new water bar

After breakfast, the group set out on the trail toward Italian Camp, pausing to collect tools stashed the prior afternoon. Leap-frogging up the trail in groups of 2-3 (**Figure 22**) to locations flagged by the Trip Leaders, the group continued to construct new water bars and soon reached the turnoff point for Skottsberg Trail.

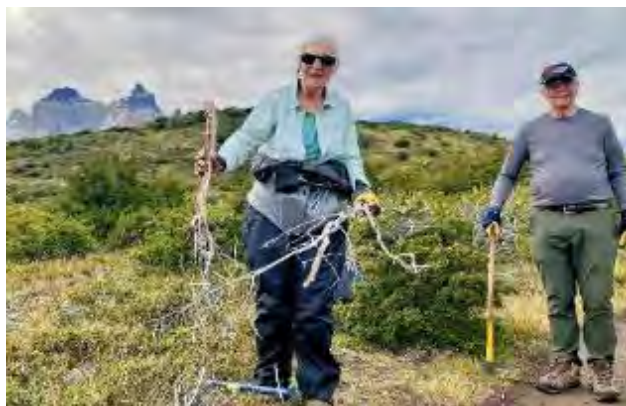
*Figure 23: A team of 2 collects loose vegetation to aid recovery on closed off, braided trails.*

itself in the tracks. The recovery was aided in some areas by lightly loosening compacted earth at the surface of the track before concealing the area with duff, downed branches (*Figure 23*), and other loose plant material (*Figure 26*).

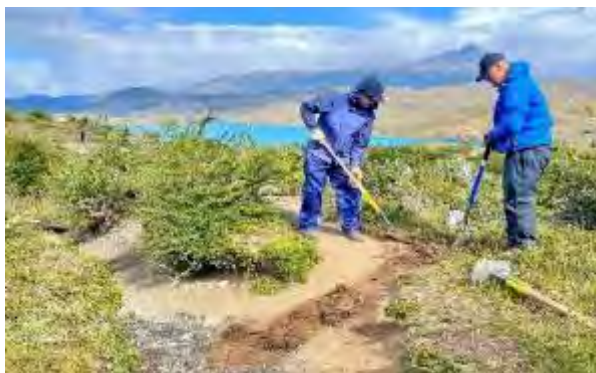
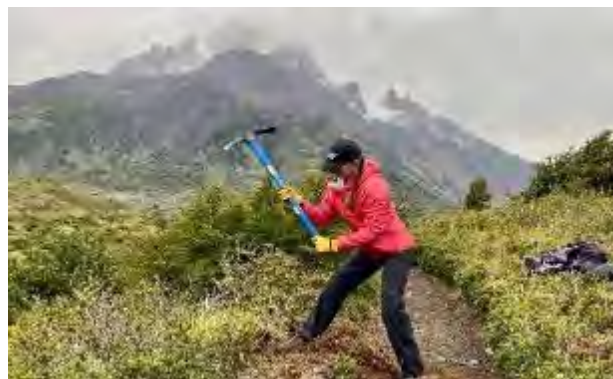
*Figures 24-25 (Left-Right): Travelers begin construction of new water bars, cutting into established banks.*

Back on the “old” trail toward Italian Camp, the group returned to construction of new water bars. Given the worn nature of this section of trail, the task was laborious. It required making deep cuts through established banks (*Figures 24, 25*), to make way for water to drain. Three teams remained committed to water bar construction, while others opted for brushing, concealment of braided tracks, and a small amount of trail revegetation. At the end of the day, tools were once again stashed off trail and out of sight.

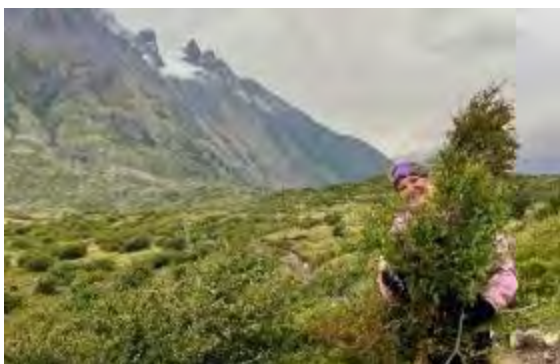
**Figure 28 (Lower Left):** The group can see a newly constructed water bar in action as rainwater is diverted off the trail; Image also shows a revegetated social bypass, directly at photo center (see Fig. 24 for before)

Returning to the location where tools had been stashed along the “old” trail to Italian Camp, the group continued installing water bars, brushing, and concealing braided tracks along another 1/4-1/2 mile of trail. Clouds loomed overhead most of the day, concealing the peaks and bringing the wettest day yet. With more rain came wet and muddy conditions! The group persevered and accomplished much. Smiles abounded as the group could see their water bars in action by the end of the day (**Figure 28**)!

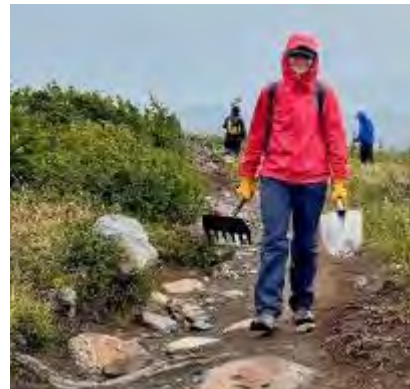
**Figure 31** (Lower Left): Revegetation in action!

**Figures 32-33** (Lower Center & Right): Newly constructed water bars

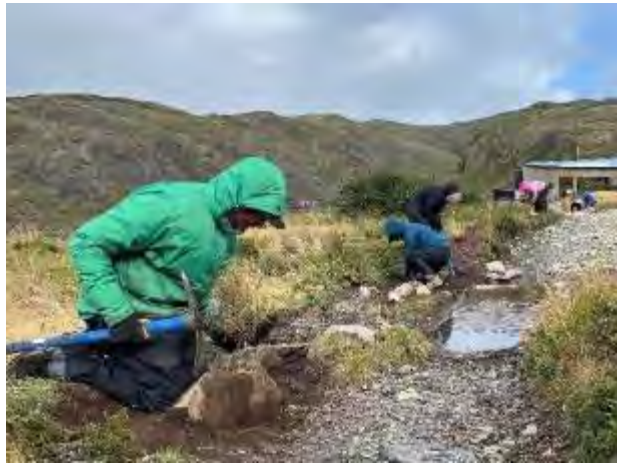
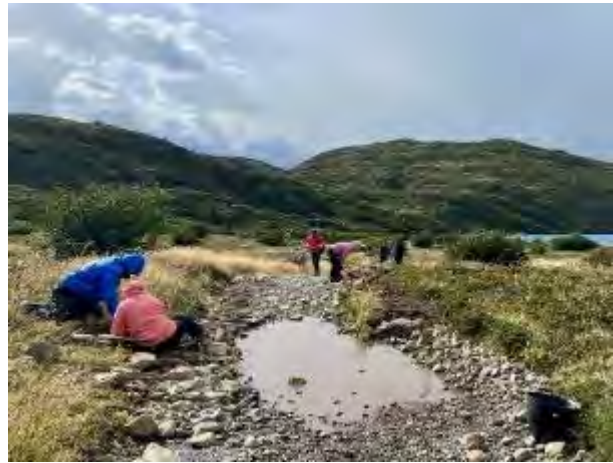
Selecting new tools appropriate for revegetation (hoes, shovels, mattocks) and some rock removal (shovels, pickaxes, buckets), the group set out to revegetate approximately 150' of worn trail. Rocks were dug in at anchor points to deter foot traffic through the route, plant material was harvested and replanted in the light patches, and duff, downed branches and plant material were used to conceal deeper braided tracks.

**Figure 35** (Top Left): the group revegetates a widening section of trail.

**Figure 36** (Top Right): the group revegetates a puddle bypass and provides rock fill to allow the main trail to be passable.

In parallel, a team of two focused on widening and improving an undersized outlet at the end of a water pipe coming from the Ranger Station, alleviating backup and flooding onto the trail. Another group of two collected rocks to infill one of the deepest puddles (**Figure 36**), creating a route for hikers to remain on trail, rather than continuing to erode the edges.

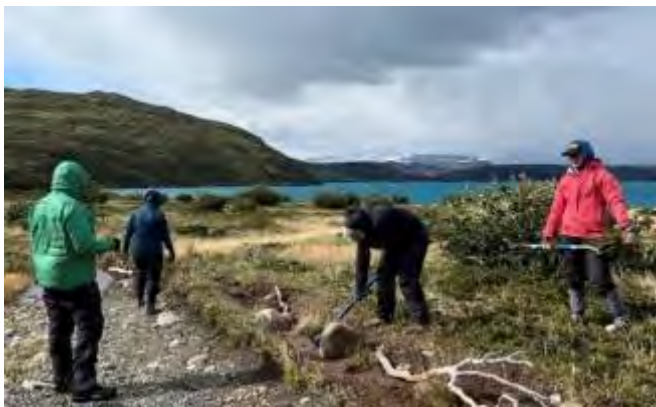
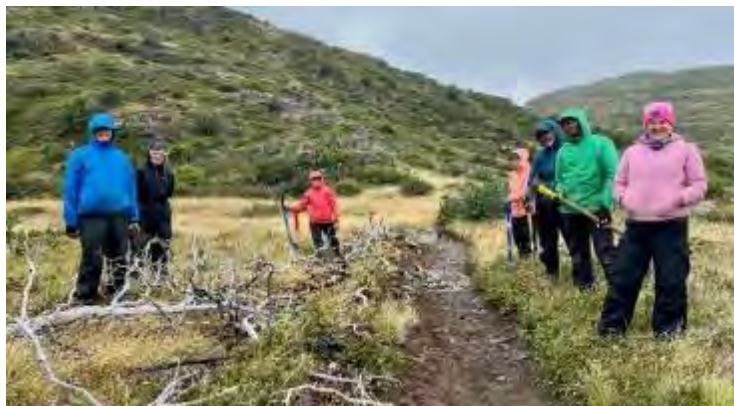
**Figure 37** (Above Left): the group revegetates and conceals a newly worn bypass trail.

**Figure 38** (Left): the group flanks a section of bypass trail that has just been revegetated and concealed.
